CALSPAN ON-SITE SCHOOL BUS/PEDESTRIAN ACCIDENT INVESTIGATION

CALSPAN CASE NO. 95-14/3

SCHOOL BUS: 1992 INTERNATIONAL CHASSIS/AM TRAN (WARD) BODY

16. Abstract <p>This on-site investigation focused on the root cause of a school bus/pedestrian accident that resulted in fatal injuries to the 14 year old male pedestrian. The accident occurred during the afternoon hours of 1995, near a designated school bus stop. The pedestrian had exited the bus, however, the adjustable tab to the right drawstring of his jacket became caught between the bifold door and the V-channel in which the door closed against along the right B-pillar. The driver immediately accelerated from the bus stop and proceeded in an easterly direction on the narrow one-lane city street.</p> <p>As the bus accelerated, the pedestrian was probably initially pulled as the drawstring remained caught in the door. He reportedly attempted to run along side of the bus and gain the attention of the driver, however, he was subsequently knocked to the pavement as his jacket was pulled off. The pedestrian's right hand swiped along the right side surface of the bus as he fell to the pavement and was run over by the right rear tires of

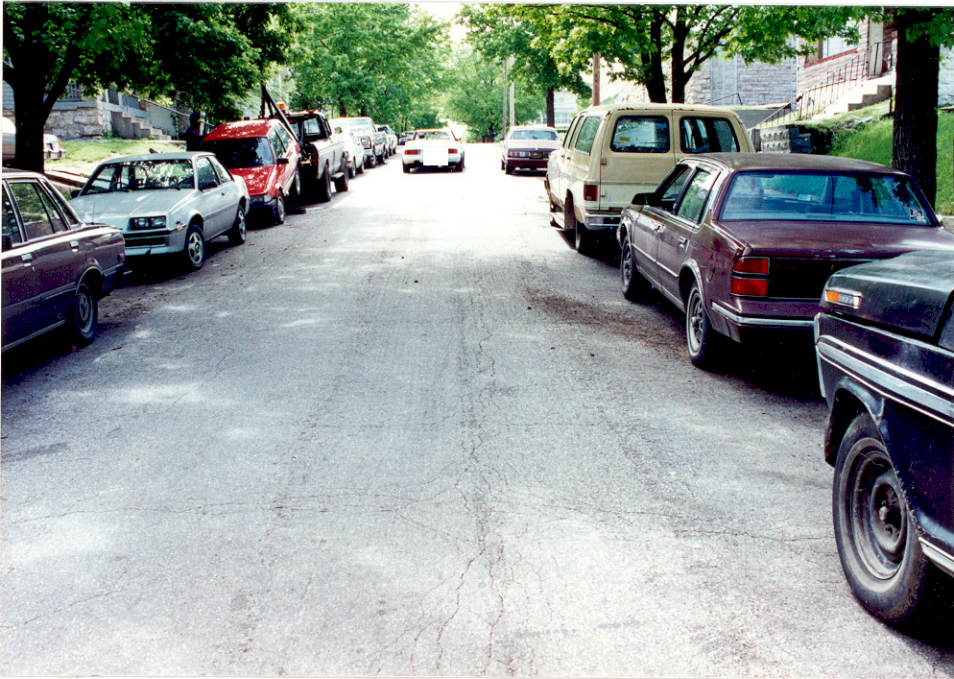
5. Bus continues forward in an easterly direction with pedestrian running/dragged along right side of bus.

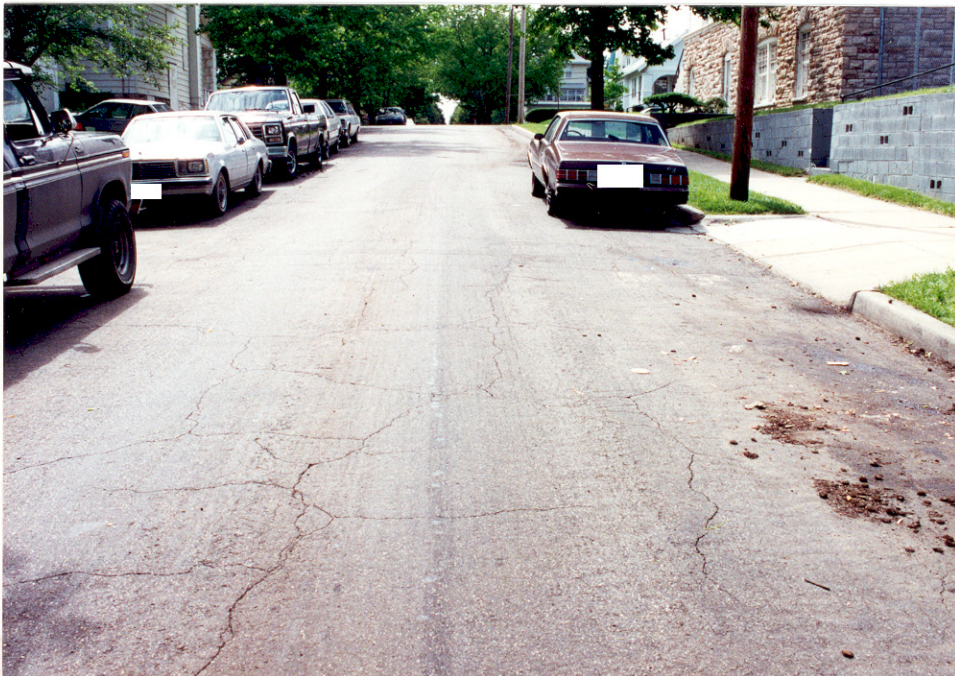
6. Area where pedestrian was run over by the right rear tires of the bus.

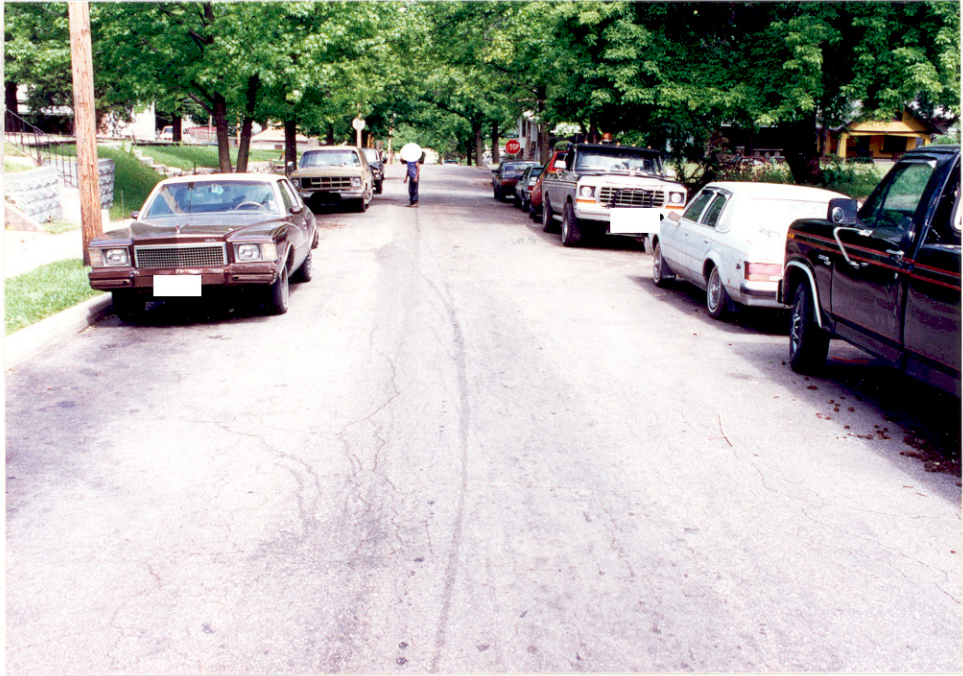
7. Lookback view of the buses' trajectory from the area of impact.

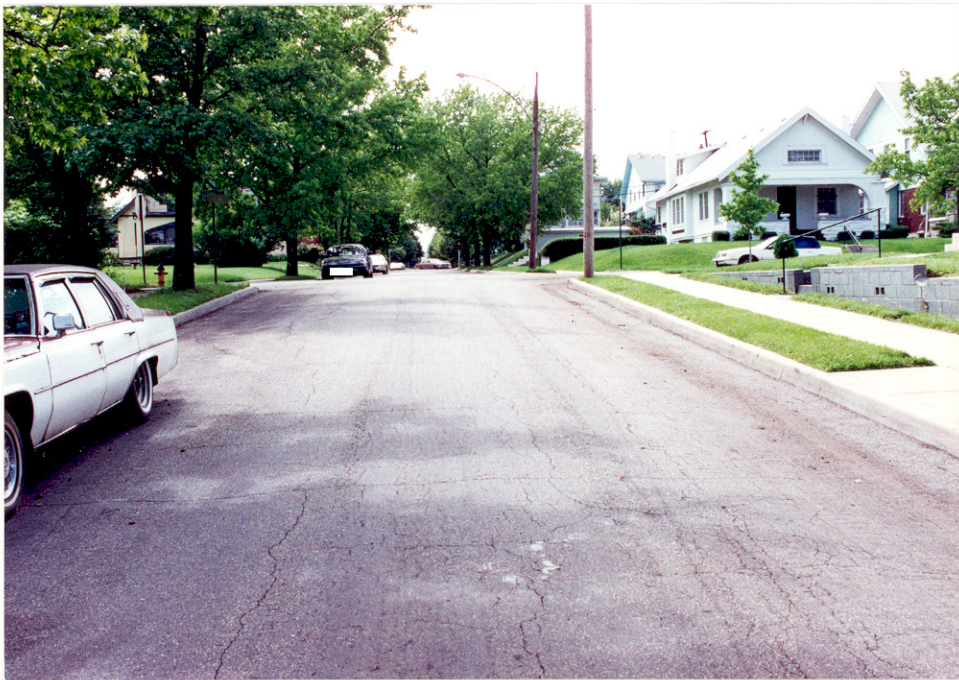
8. Continued trajectory of the bus post-event.

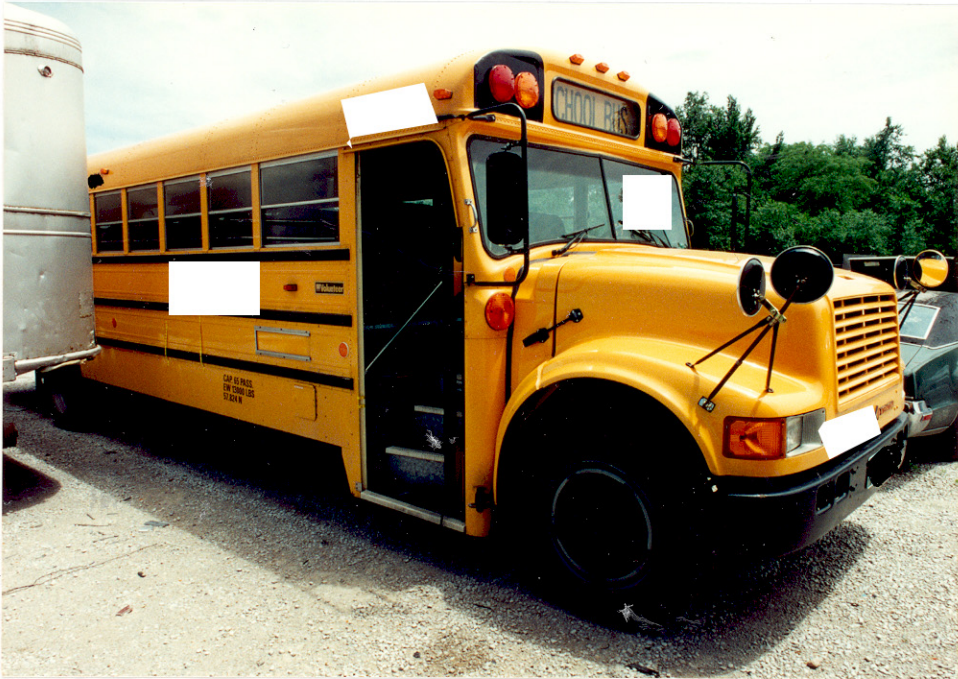
13. Right front three-quarter view showing the mirrors and door area of the involved bus.

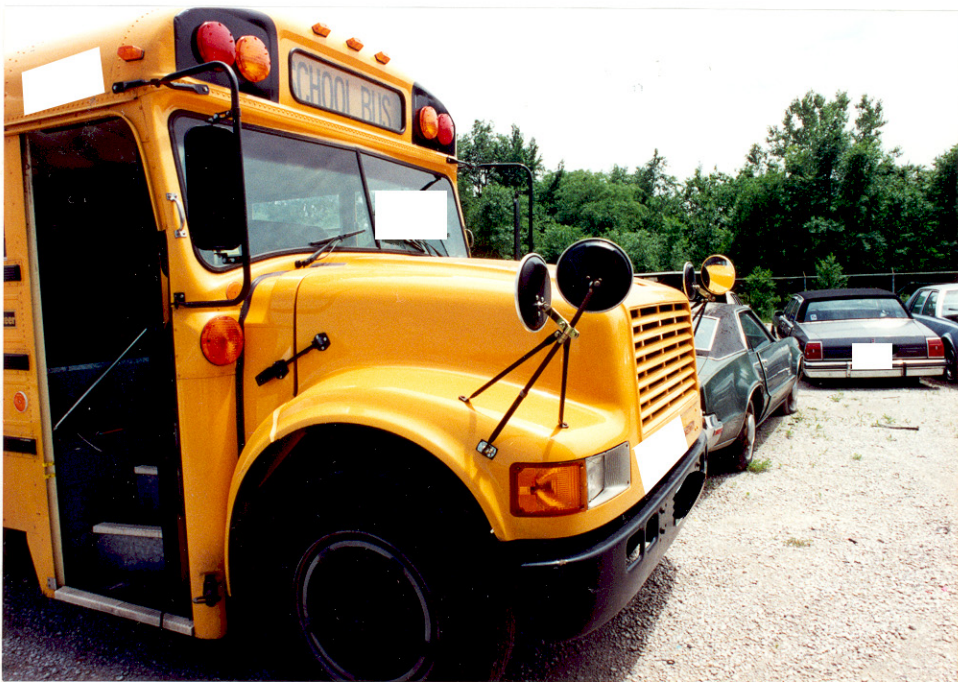
14. Close-up view of the convex and plane (flat) mirrors.

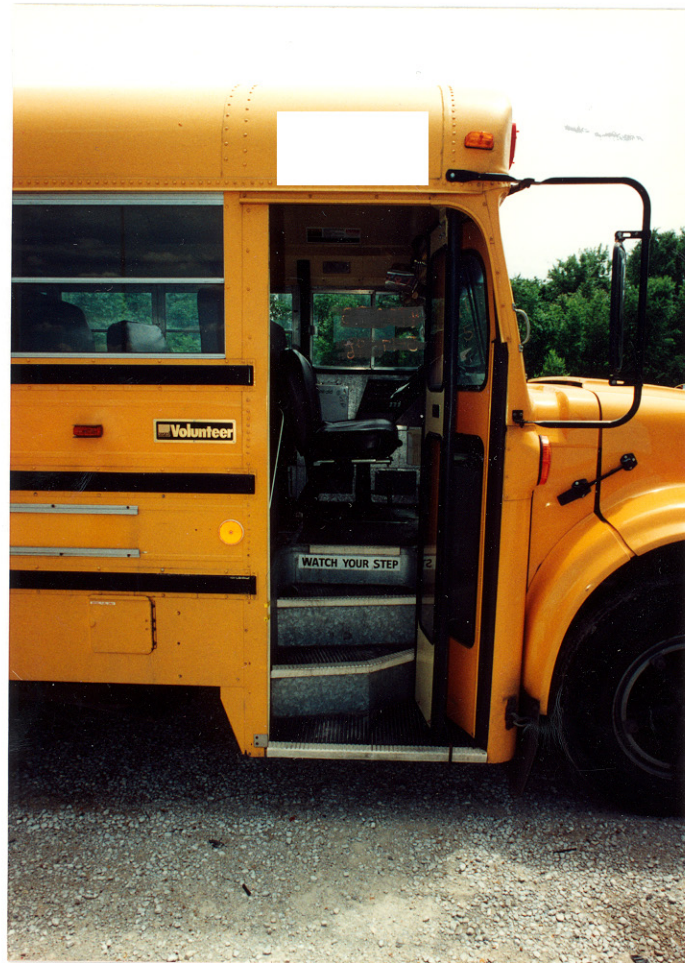
19. Interior view of the bifold doors and stairwell.

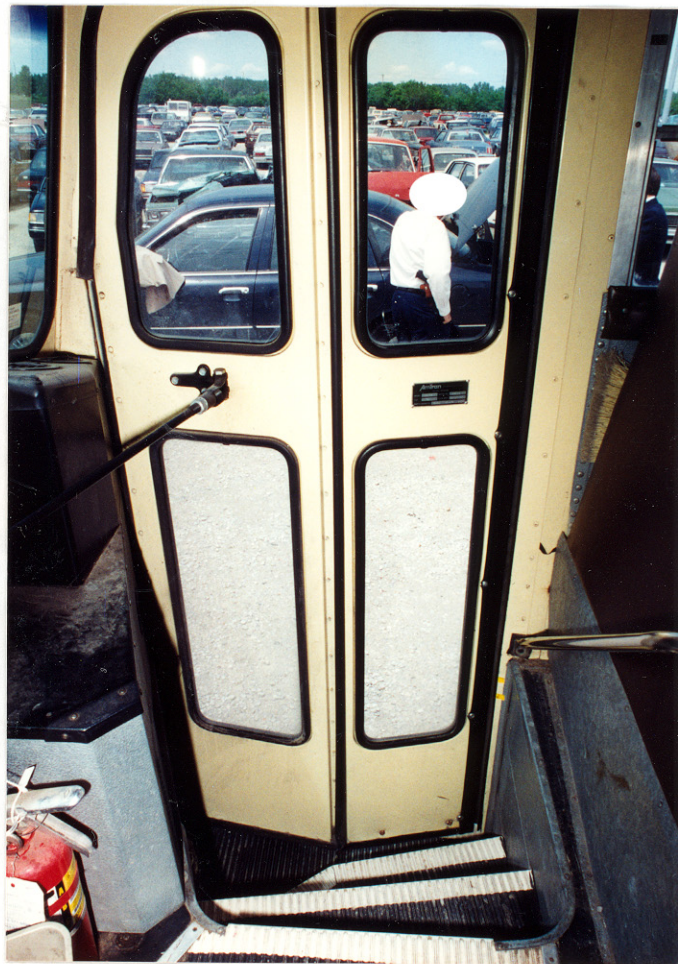
20. Overall exterior view of the door and stairwell.

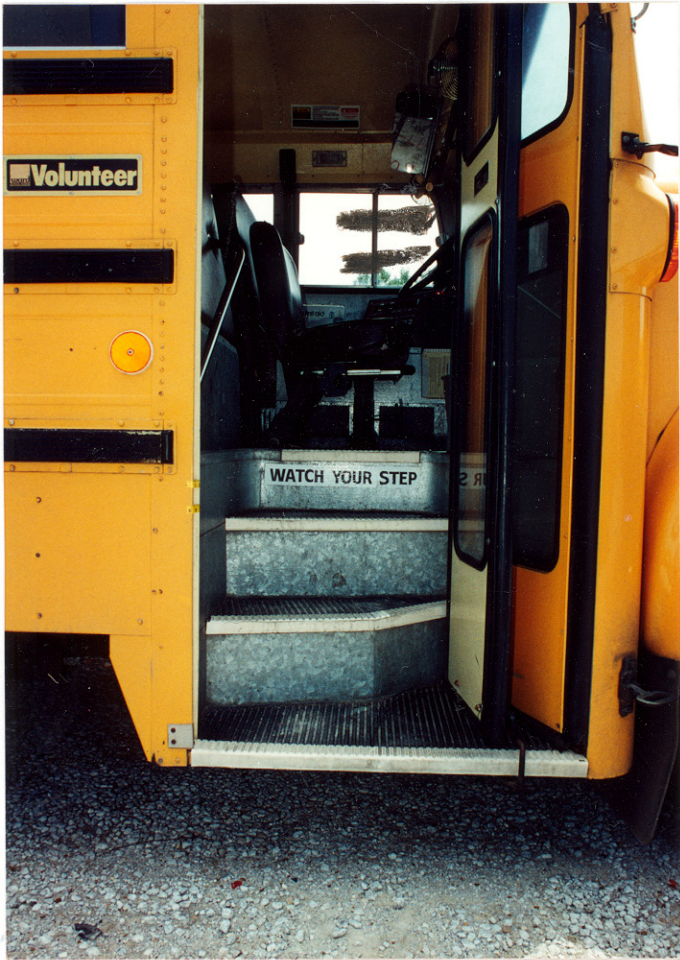
21. Close-up view of the door area.

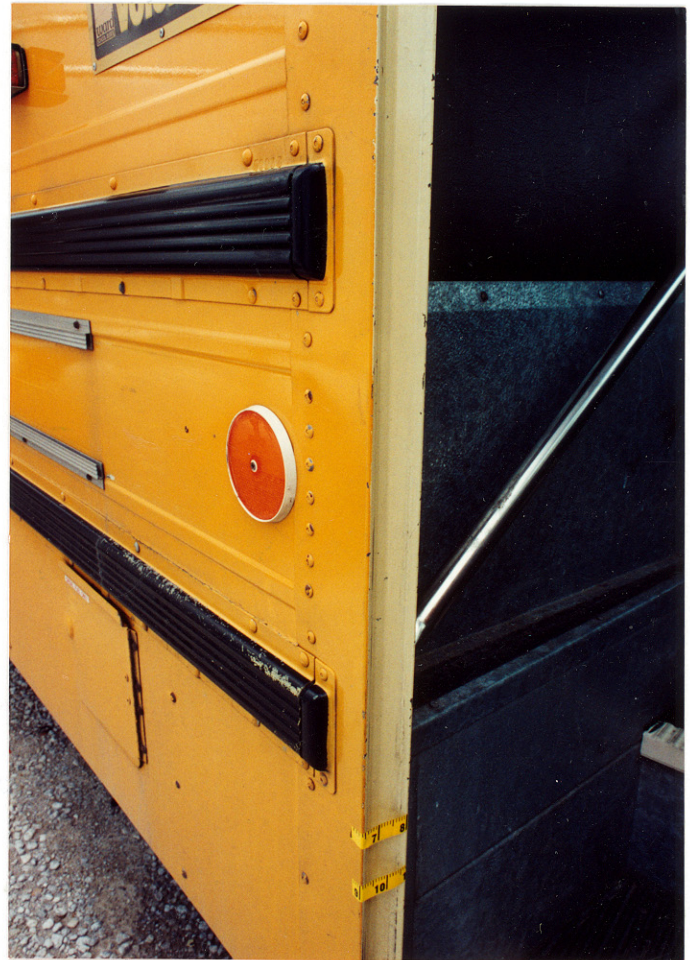
There were two possible components that could have allowed the drawstring to become caught in the bus. The components are the door/V-channel and the base of the handrail. The handrail was ruled out as a possible mechanism by two sources; the bus driver's statement that he observed the jacket (drawstring) fall as he opened the door and the inability to recreate a snagging of the actual drawstring following numerous tests over the handrail configuration. The large tab and the rounded corners on the tab prevented the drawstring from becoming snagged on the rail. The modified foam rubber pad contributed in deflecting the tab away from a possible snag point. Another style of drawstring tab could become snagged between the rail and the previously identified screw hole as documented in Photograph Nos. 44 and 45.

22. V-channel along right B-pillar.

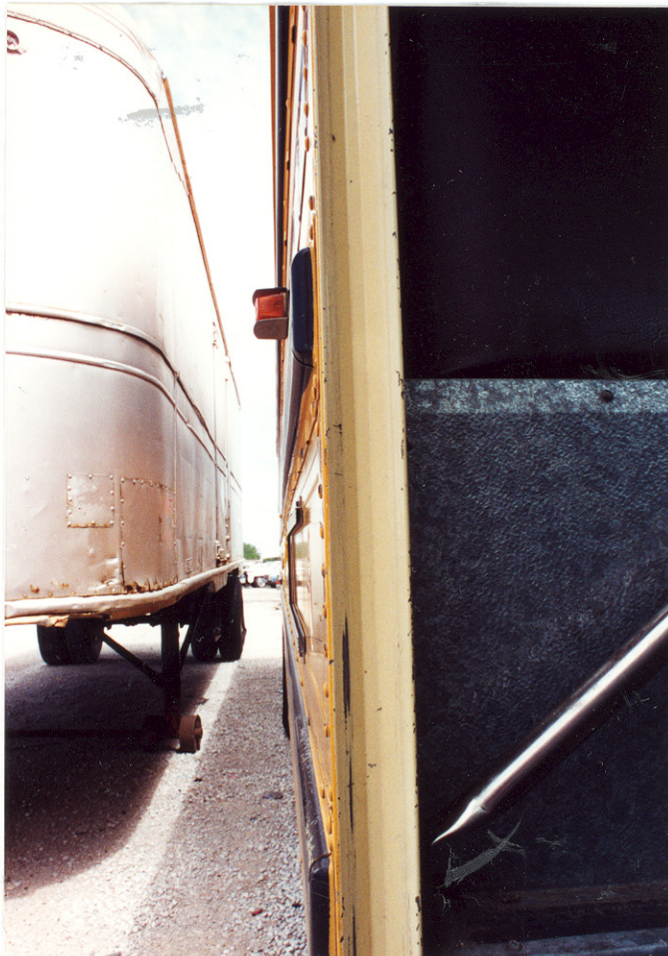
23. Additional view of the V-channel.

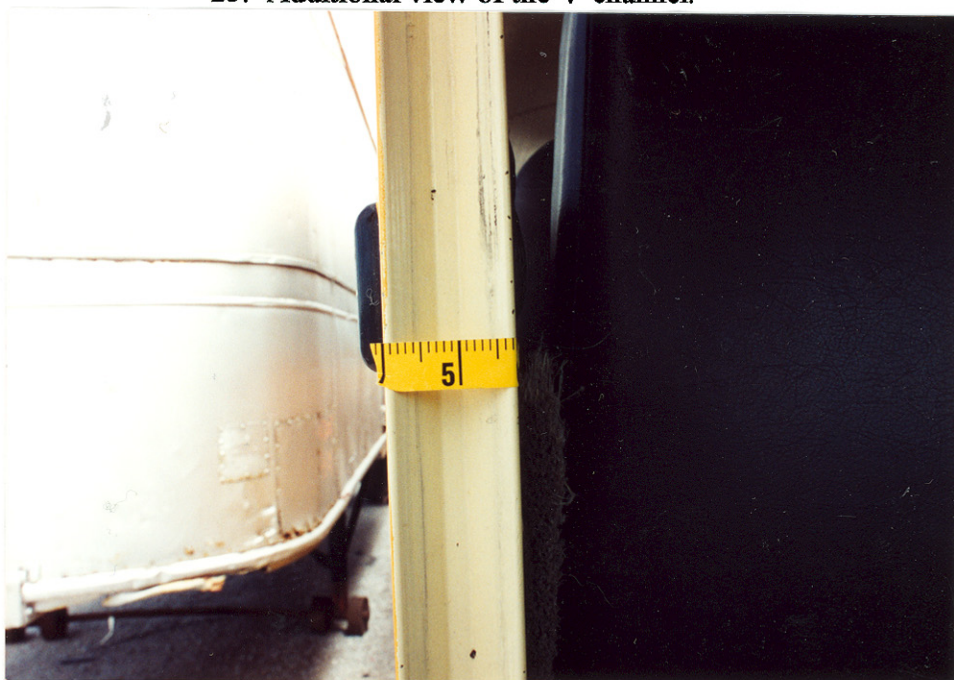
24. Close-up view of the V-channel.

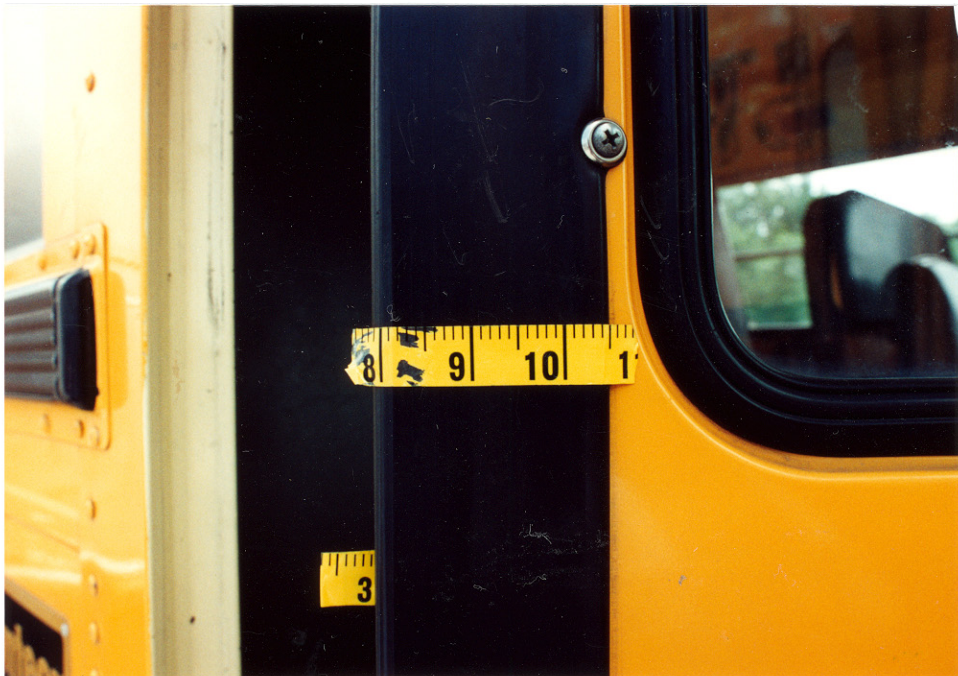
28. Width of the door weatherstripping/gasket on exterior surface.

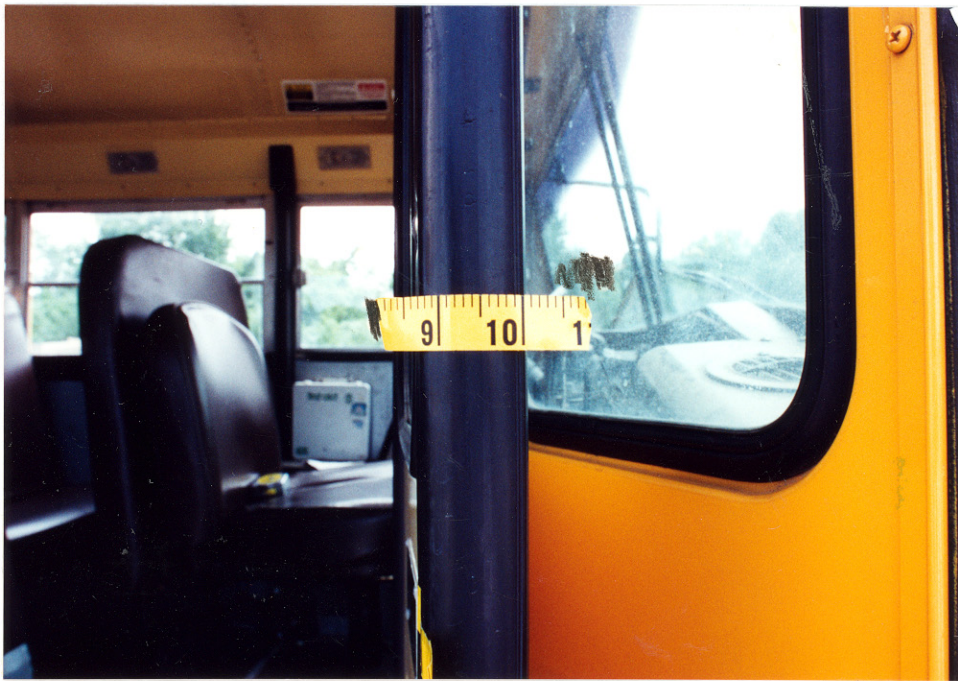
29. Thickness of the rubber weatherstripping/gasket.

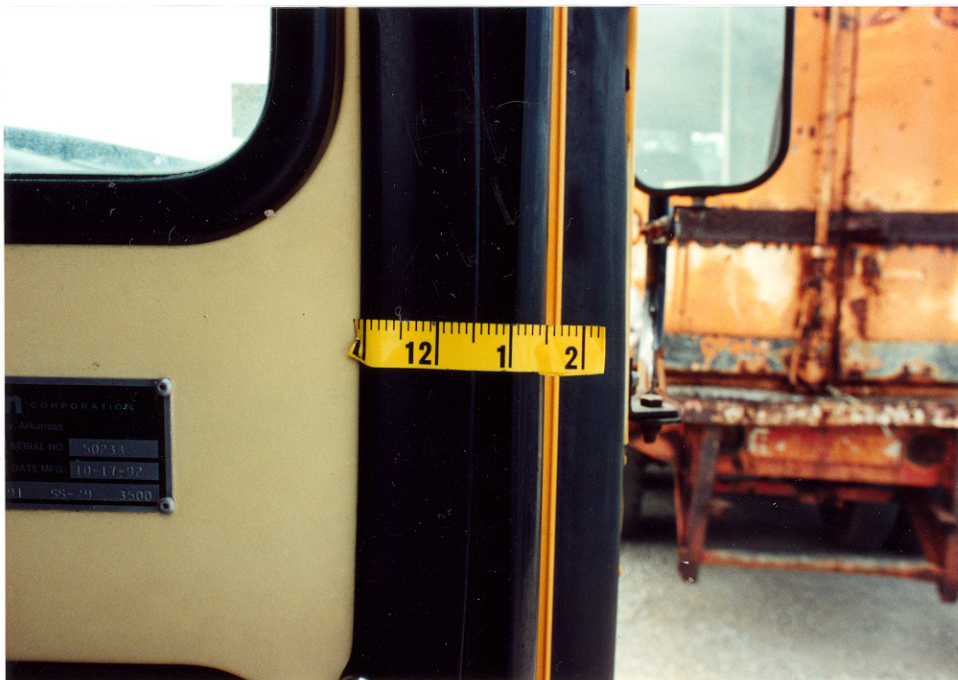
30. Interior width of the weatherstripping/gasket.

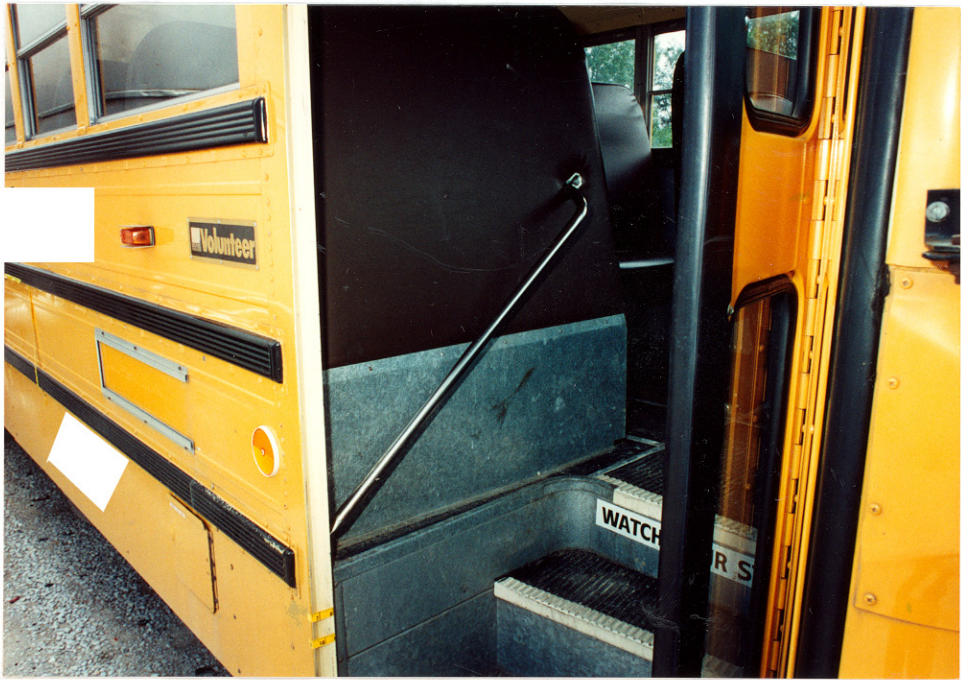
31. Overall view of the stairwell handrail.

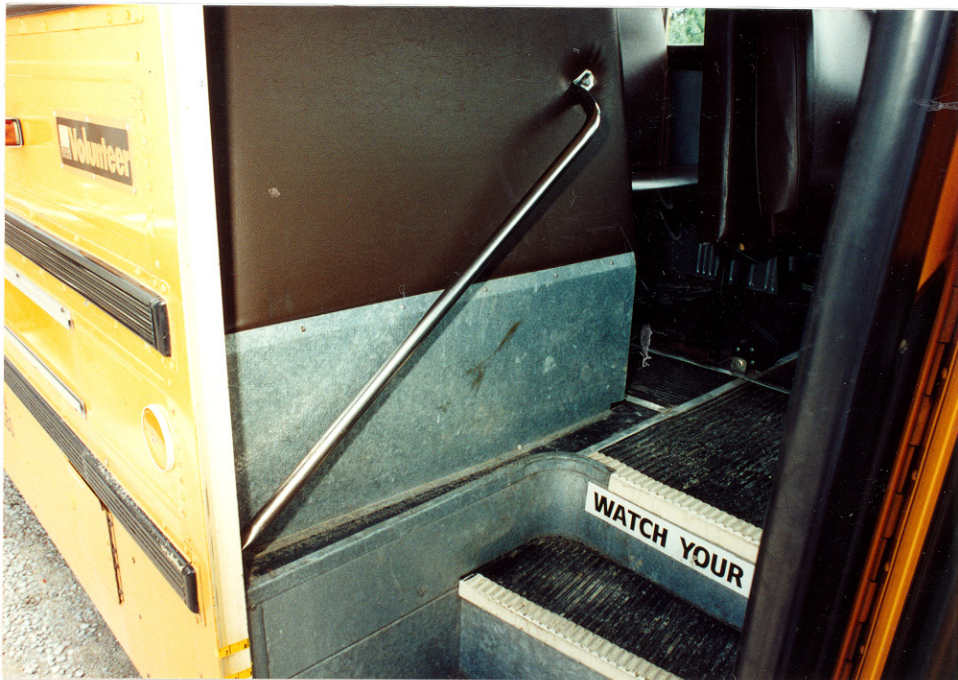
32. Additional view of the handrail.

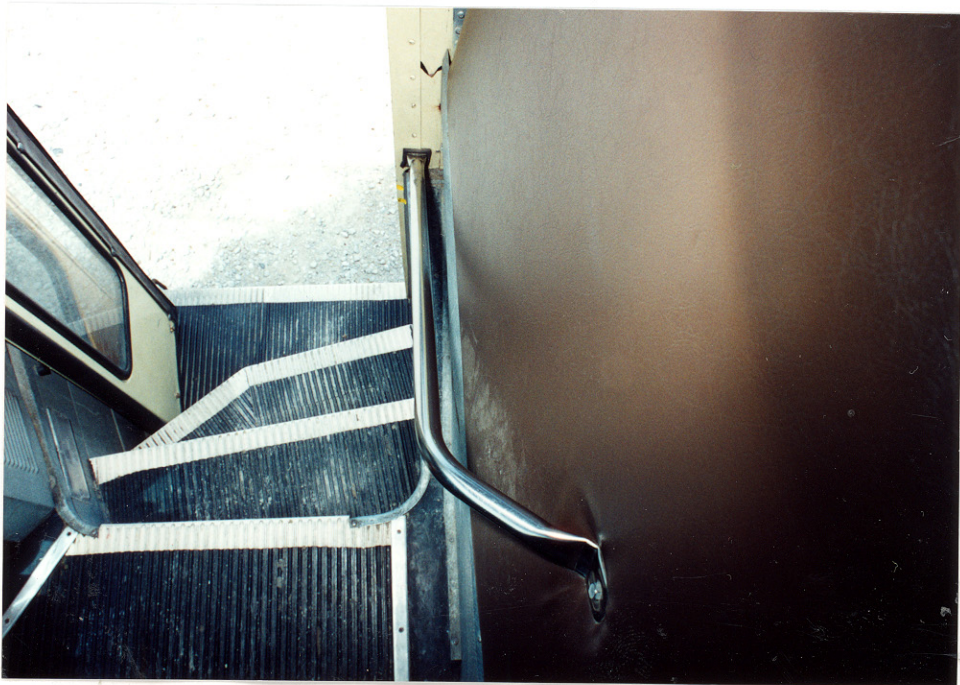
34. Longitudinal view of the handrail.

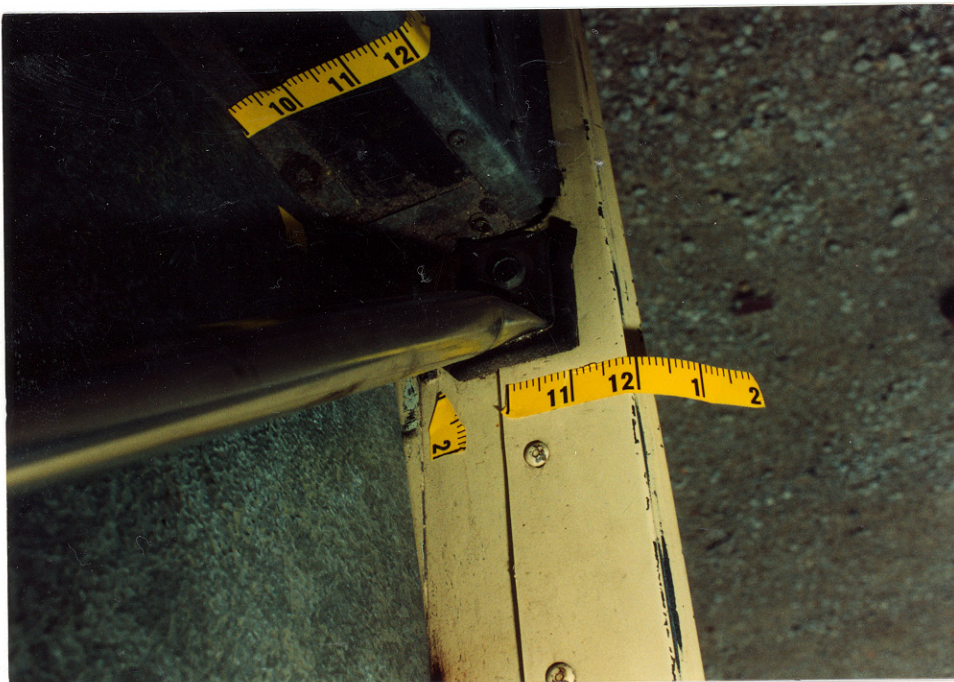
38. Offset between the handrail and the V-channel at the trailing edge of the door opening.

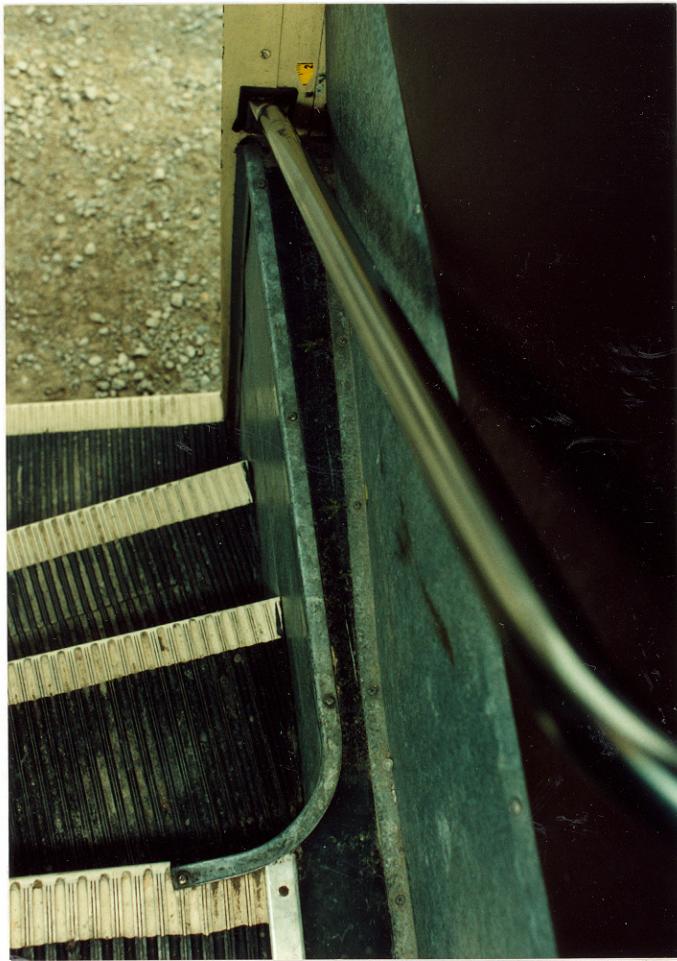
39. Longitudinal view of the modified placement of the lower kick panel.

When you return the enclosed postage paid reply card, an inspection and repair kit will be sent to you. The remedy will be to install a rubber pad on the grabrail where it attaches to the wall and to move the modesty panel to the rear far enough to attain 1 1/2" of clearance with the grabrail. You may make these repairs yourself or take your vehicle to your dealer on a mutually agreed upon service date. If he does not remedy this condition without charge on or within 5 days, you can obtain assistance by calling Customer Service at the toll free number listed below. You may also wish to submit a

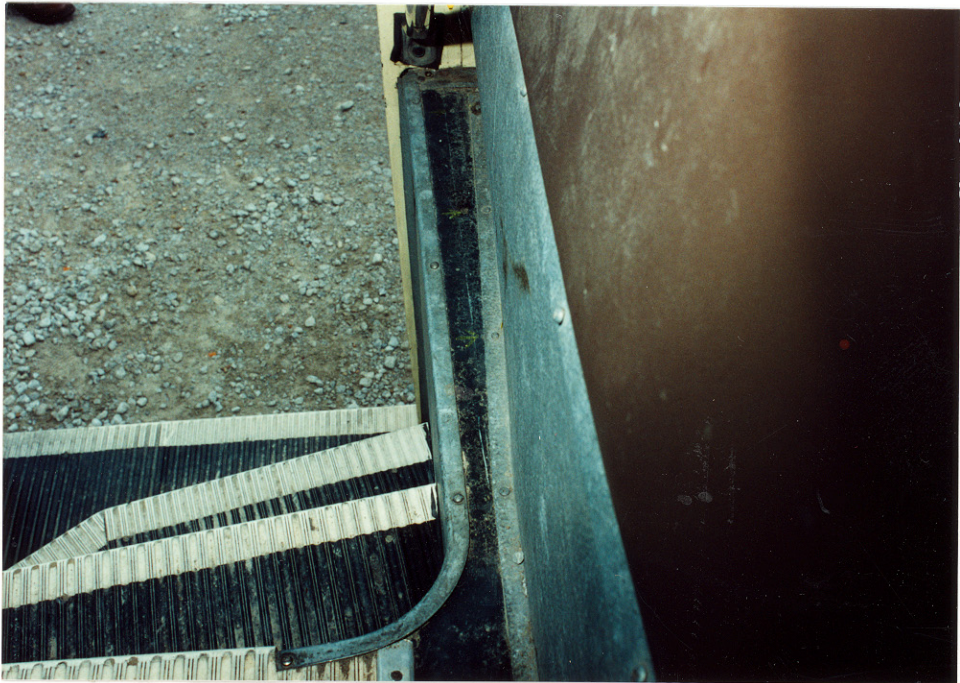
40. Visible line highlighted with yellow arrows indicates the original placement of the kick panel.

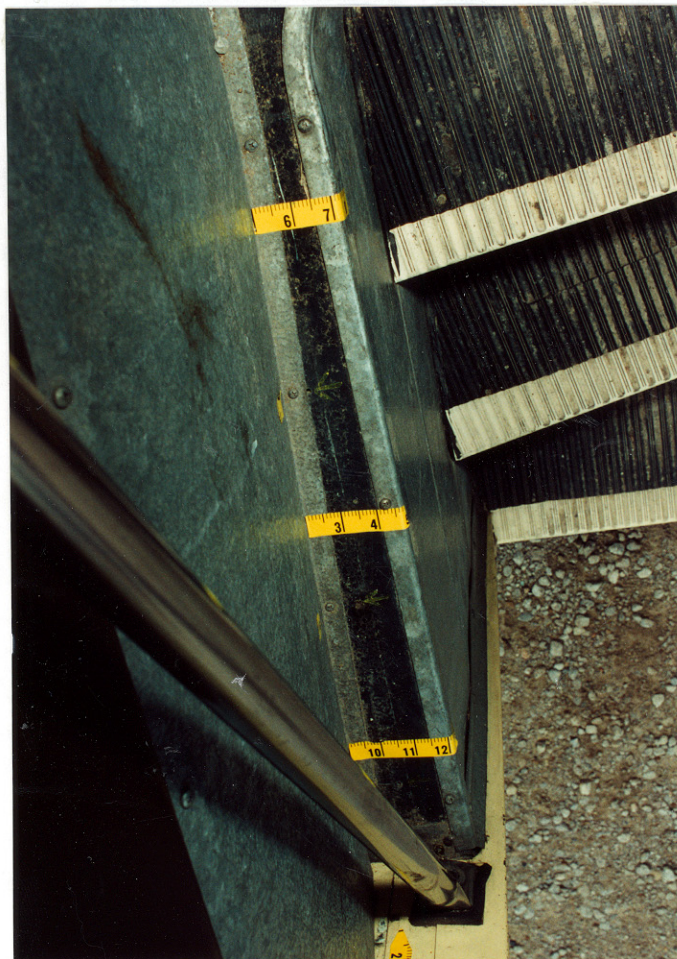
41. Calibrated tape documents the distance that the kick panel had been repositioned.

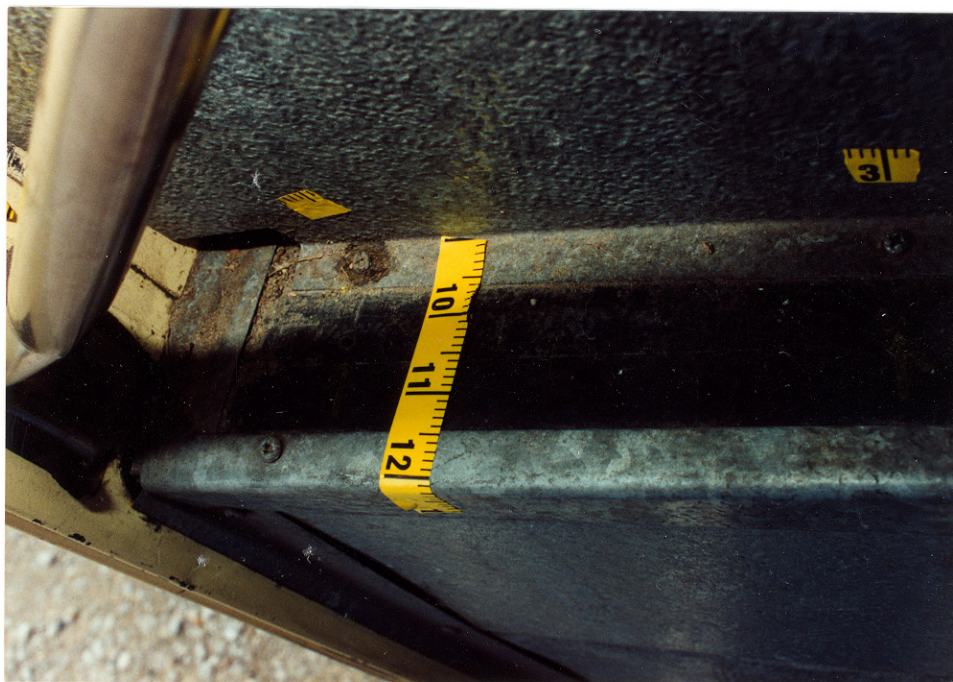
42. Close-up view of the repositioned kick panel at the outboard corner.

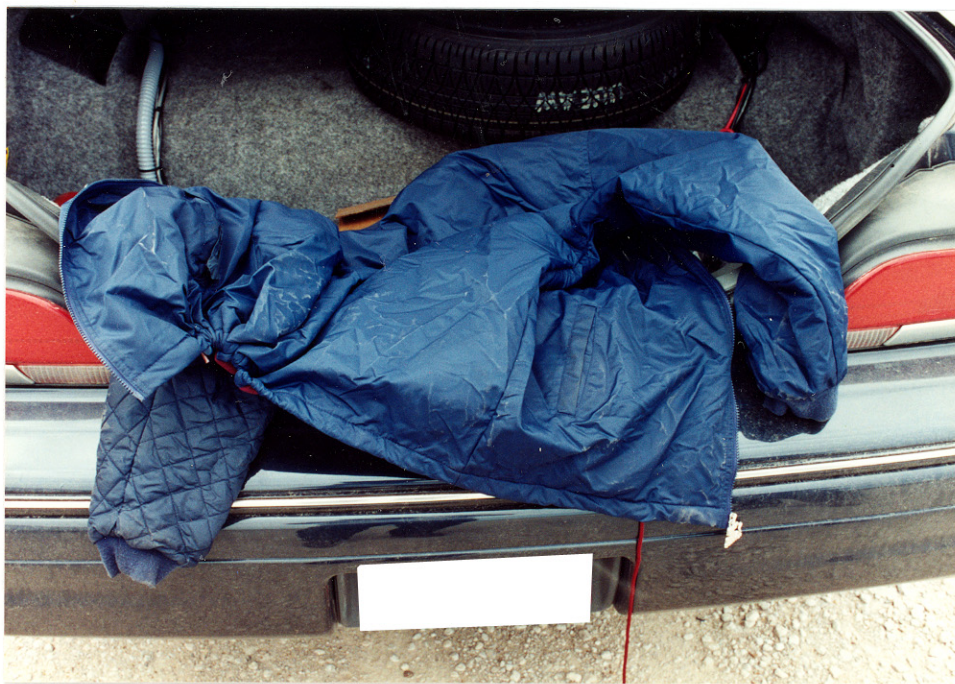
46. Overall view of the exterior of the pedestrian's jacket.

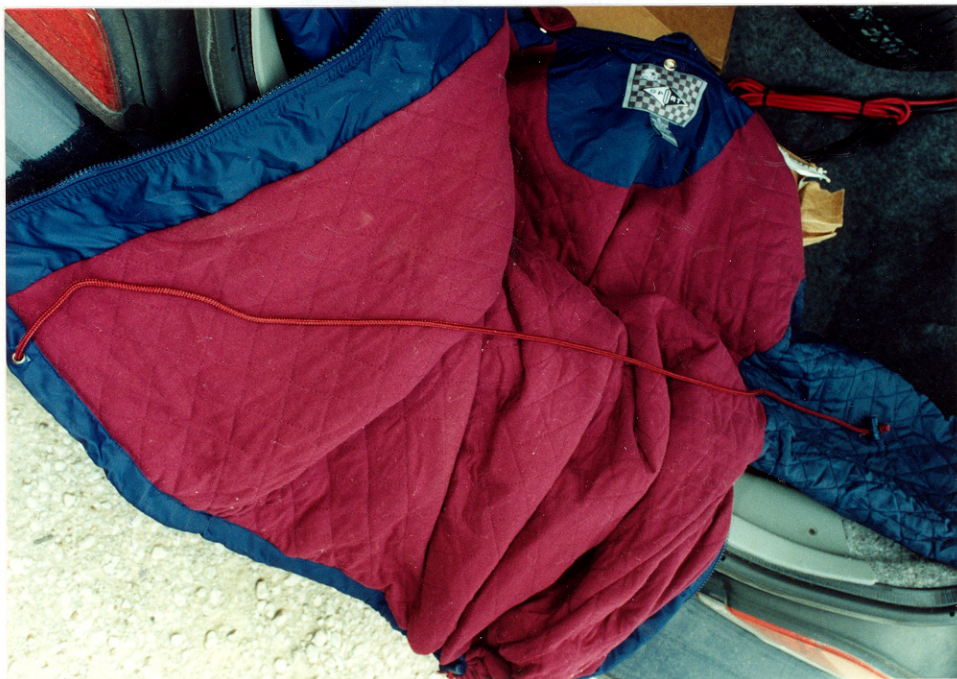
47. Inside (lining) view of the pedestrian's jacket.

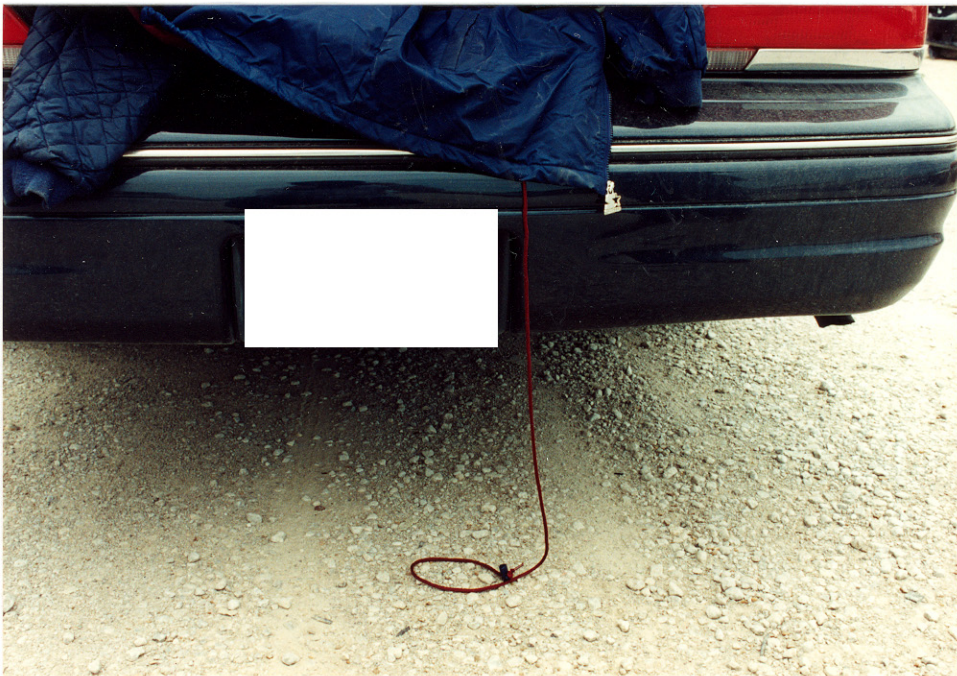
50. Full length of the drawstring (41") which was pulled out of the right side of the jacket.

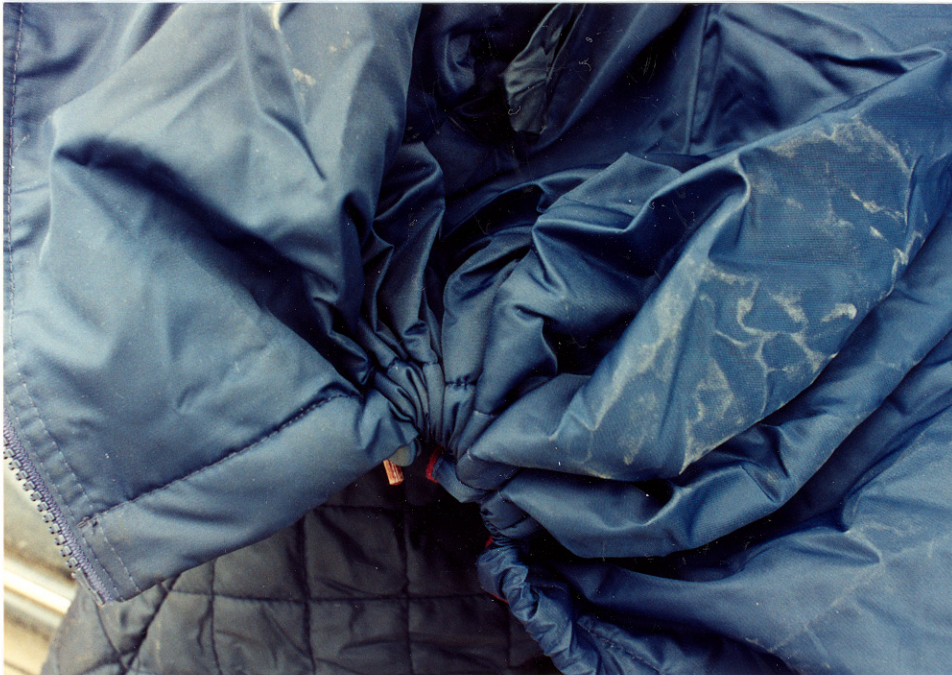
52. Gathered fabric at the left side of the jacket from the pull on the drawstring.

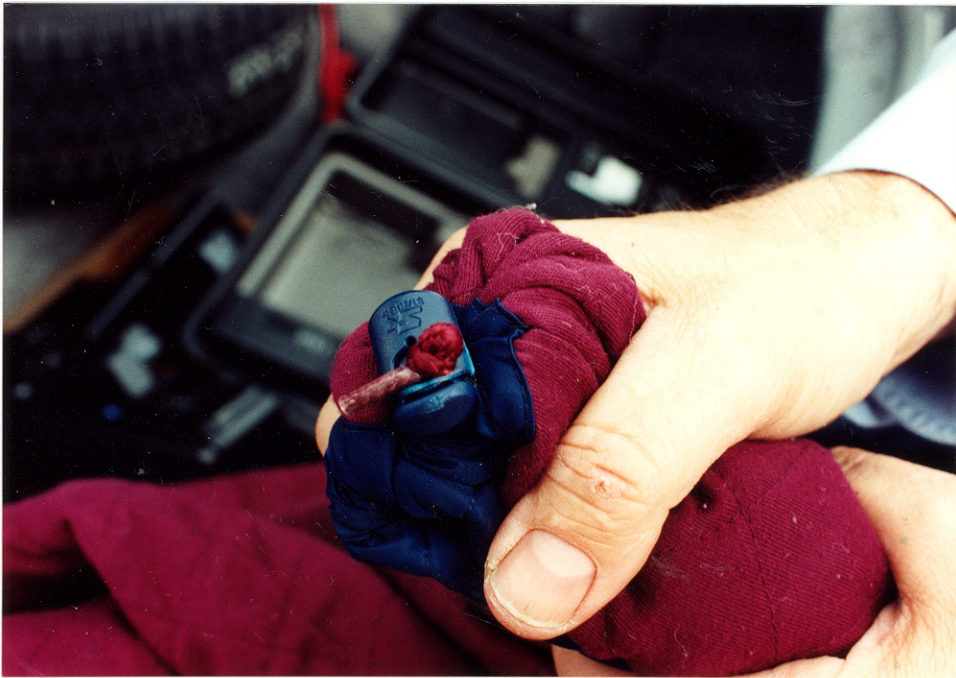
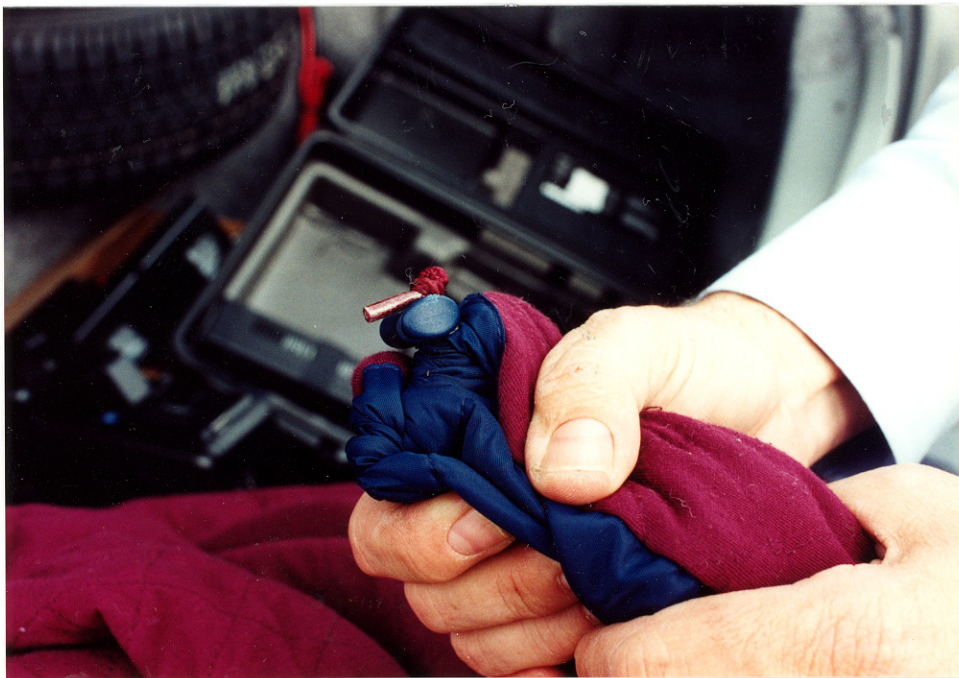
53. & 54. Left side adjustable tab.

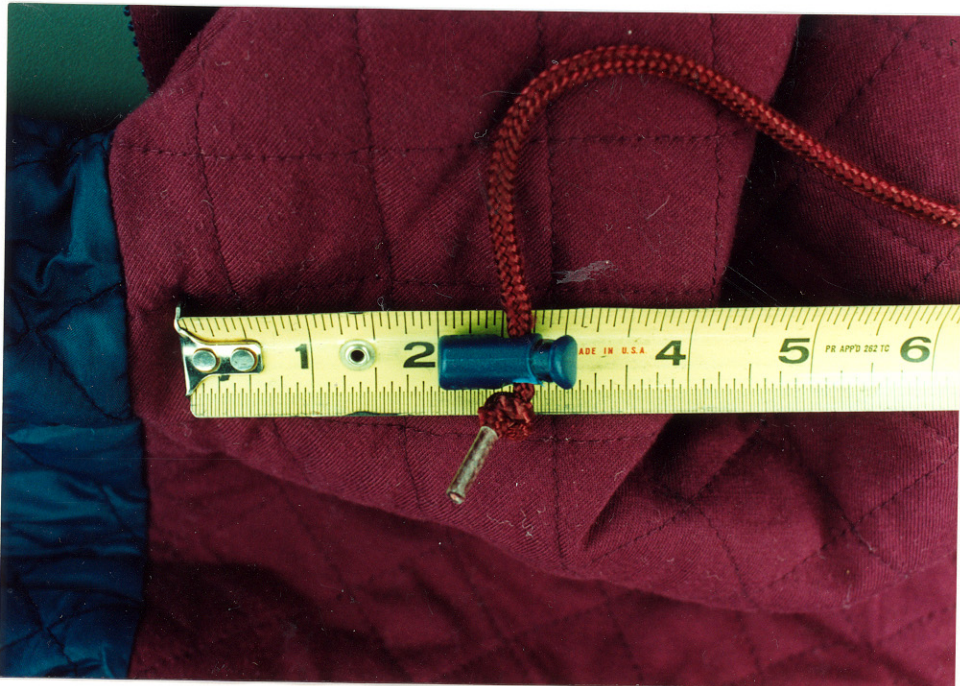
56. Overall length of the adjustable tab (1 1/16").

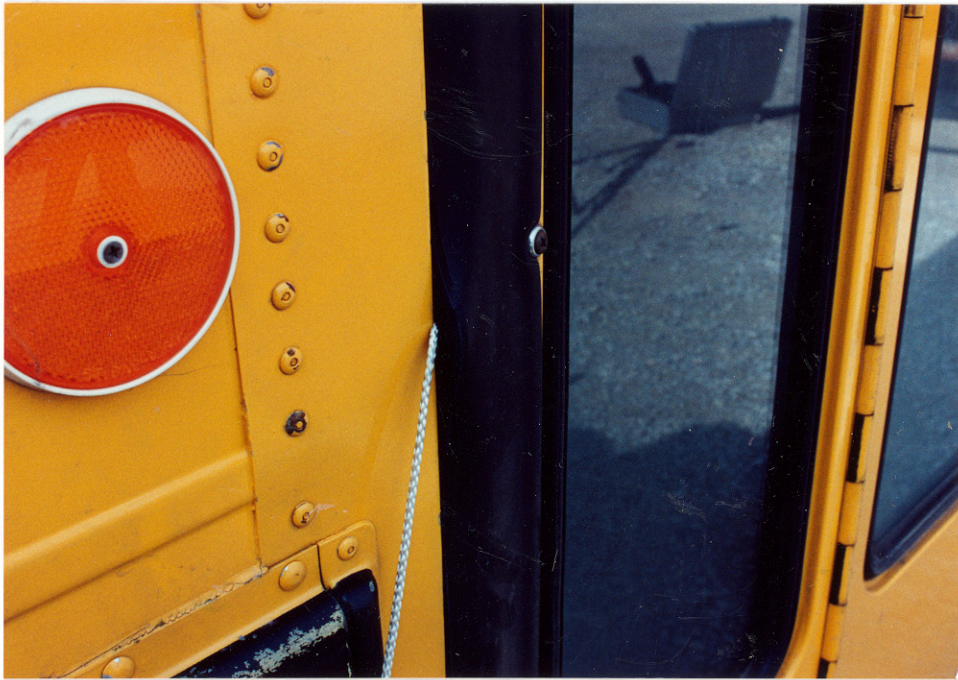
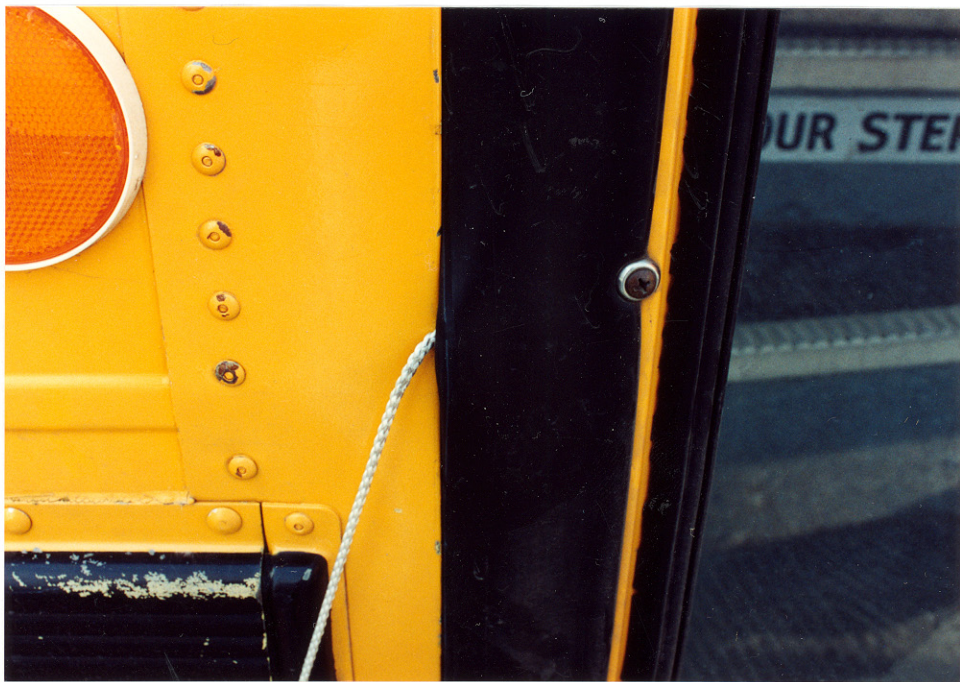
63. & 64. Exterior views of the drawstring extending from the door/V-channel juncture.

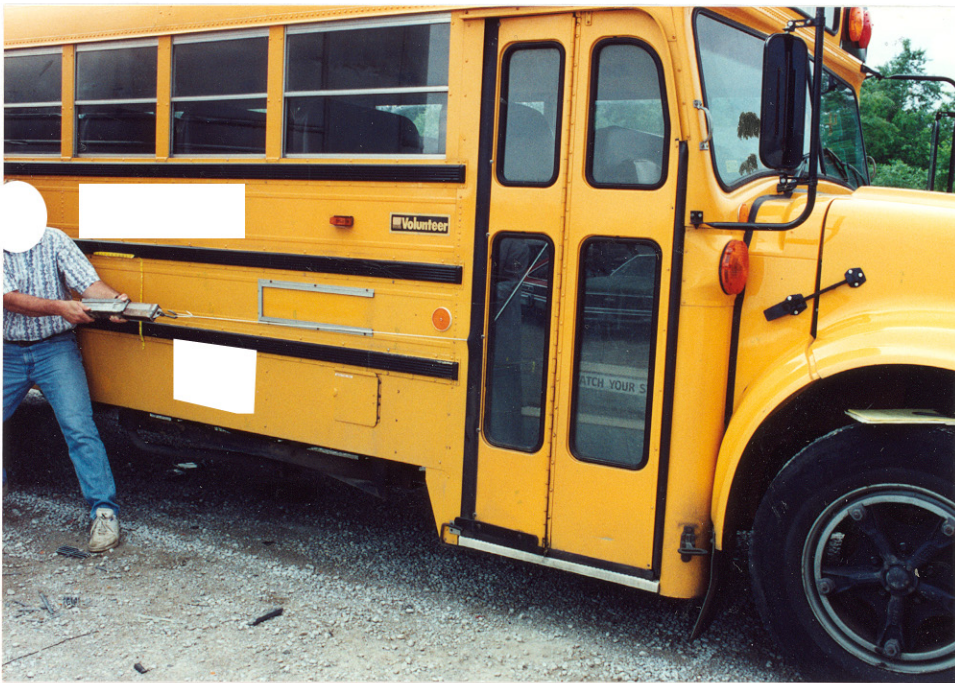
65. Overall view of the pull test using a spring scale to measure the force exerted on an exemplar type drawstring.
